## Water Treatment Plant

### Ground Improvement – Installing Aggregate Piers

#### PROJECT OVERVIEW

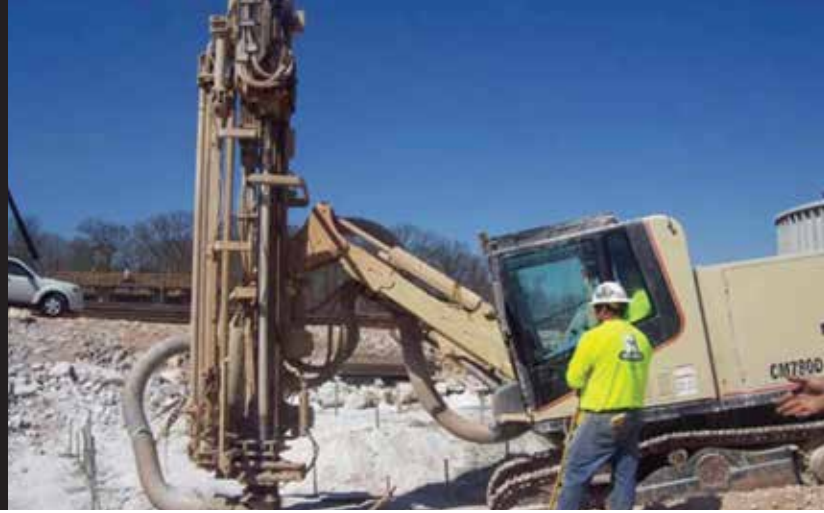
A regional water treatment plant recognized that the concrete wall slope in one of their levees was experiencing a failed slope due to a crack in the concrete. Water treatment plants have levees surrounding their large tanks that assist in water containment. A crack in the concrete floor would prevent one of the levees from properly containing the water, exposing the foundation to leaks.

We used helical piers to provide permanent slope stability because they provide high-capacity capabilities and offer instant tension resistance. Working in conjunction with a concrete contractor, we installed a grid pattern of helical piers in a W formation and tied the pattern into the new concrete for slope stabilization. Our turnkey solution allowed our internal team to offer a quote in just three days, and we were able to start installation in under one week. We retained the assistance of a concrete contractor and were able to complete the installation of the helical piers in just over two weeks.

CNC Foundation's turnkey solution kept the process on time and within budget. Because of our rapid response and efficient installation, the plant resumed operations in under one month. Our permanent solution will ensure the levee slope remains stable and will prevent additional cracks from forming on the concrete slope.
